**Eradication of the non-native carpet ascidian  
(sea squirt) *Didemnum vexillum* in Holyhead  
Harbour: Progress, methods and results to  
spring 2011**

**Rohan Holt and Ashley Cordingley**

**CCW Marine Monitoring Report No. 90**

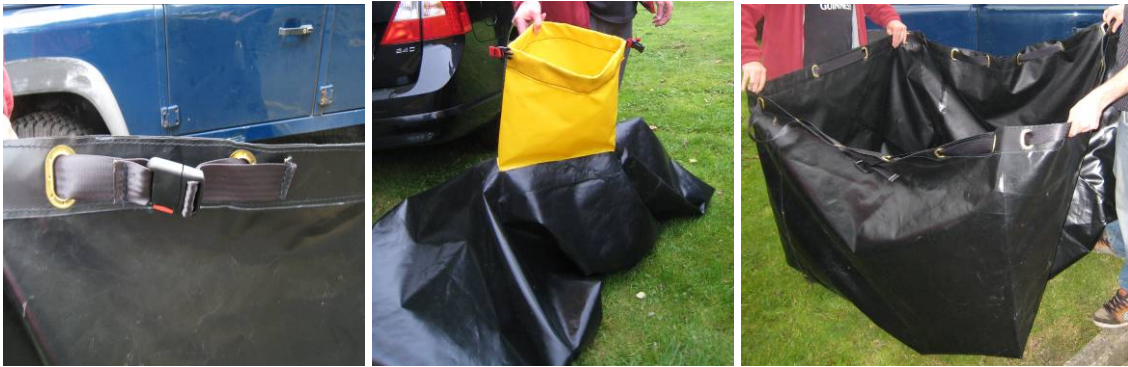
**Figure 5** Draw string prototype finger pontoon bag.

The most successful draw-string and elasticated bags were made from 600 GSM (grams per square meter) PVC. The combination of lightweight fabric and loose-fitting design allowed rapid fitting by snorkellers to the smaller pontoon floats - often in less than 4 minutes per unit. Excess water was pumped out using a petrol-driven centrifugal water pump after fitting.

had to be on hand to close them which slowed the whole process. Openings were subsequently omitted from new bags or left closed during fitting.

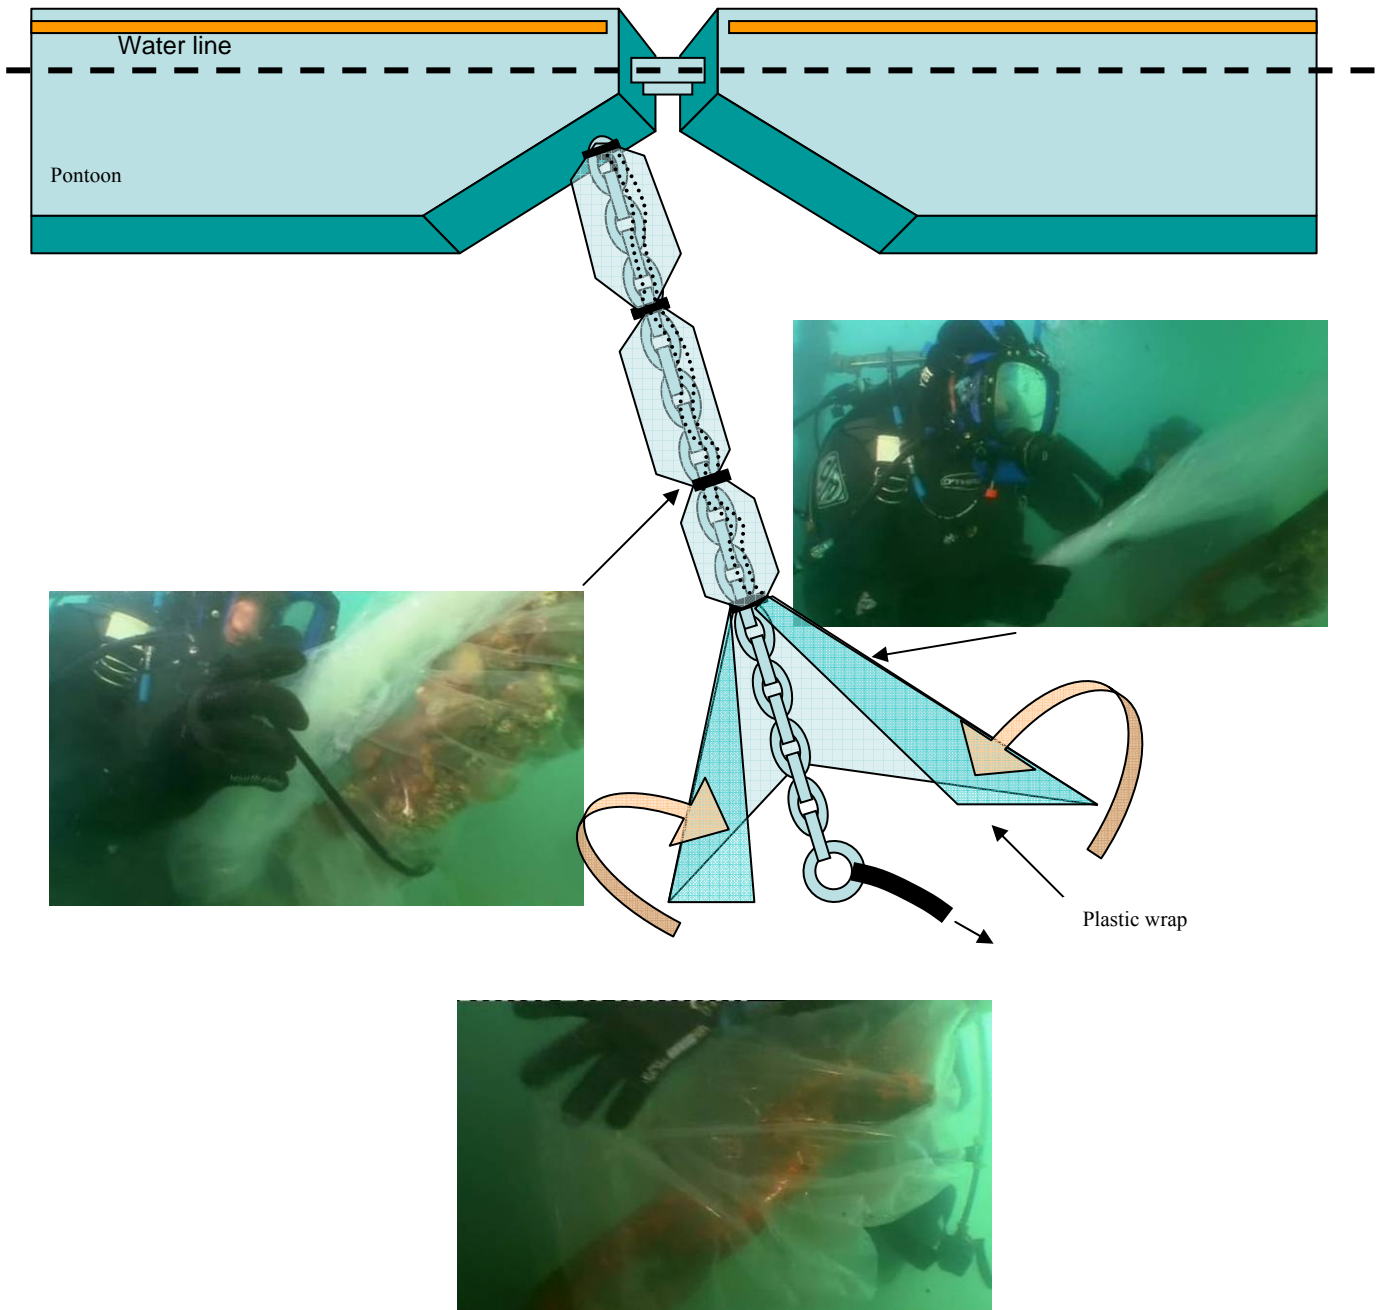
**Figure 20** Chain wrapping method **Removing wrappings from chains**

Ten metre lengths of sheet plastic were cut from the supplied roll and re-rolled onto plastic tubing (usually drain pipe slightly longer than the width of the plastic) with the loose end taped to prevent unrolling before deployment. A rope lanyard with a karabiner was fed through the tube to make a sling for the divers to carry.

Large (>500 mm long x 9 mm wide) cable ties were used to secure the sheeting around the chains. ‘Dispensing racks’ of 50-100 cable ties were prepared to allow the divers, wearing thick gloves, to pull them off the rack as required. A rack is prepared by simply cutting the ratchet head off one tie then feeding all the others on to that tie, leaving sufficient length at the ‘tail’ end to tape a loop into a karabiner to clip to the diver’s harness.

A dive pair need to work as a team; one diver dispensing and holding the plastic in place a couple metres at a time around the chain, while the second diver rolls and secures the sheeting onto the chain with cable ties to create a near-watertight seal. Cable ties need to be placed every 40-50 cm to prevent the plastic from unraveling and water from flushing along the wrappings (**Figure 20**). For the long chains on all the breakwater pontoons one or two additional rolls of plastic were used to reach the desired length.

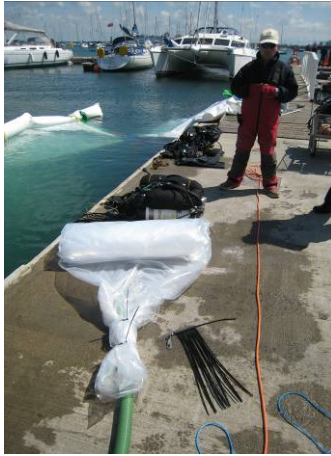
**Figure 23** Spacer deployment method. The rolled up bag attached to the water pump outlet on the surface

These were constructed from a length of polythene tubing just over double the length of the space to be filled. Each section was folded inside-out to form a double thickness tube just longer than the width of the pontoon. One end was sealed by folding over the material and cable-tying it in place, and then the bag was tightly rolled to exclude as much air as possible (**Figure 23**). The outflow pipe of the water pump was then inserted into the open end of the bag and temporarily secured in place with cable ties or cord.

The complex topography associated with the undersides of many larger and older sections of the marina (RNLI and fuelling berths) necessitated the use of inert, water-filled 'sausages' to fill dead space (**Figure 23**, **Figure 24** and **Figure 25**). Tubes of 500 gsm clear polythene were cut to size then filled with water *in situ* to displace approximately 2.5 m<sup>3</sup> of 'free' water.

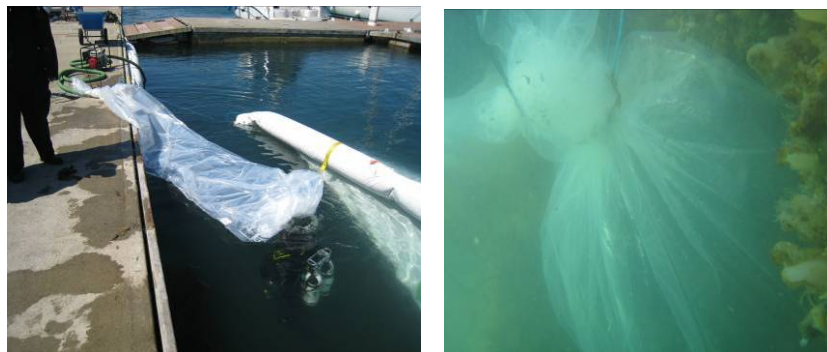
**Figure 24** Diver deployment of space filler.

The dive team then positioned the tube in its place under the pontoon and the surface crew pumped water into the tube. Diver to surface communication equipment was essential for this operation to ensure the tubes were not over inflated with water.

Once the pump was stopped and its outflow pipe removed, the end of the bag was quickly sealed closed by tightening the cable ties. Any air bubbles in the tube added a small amount of buoyancy which kept it pressed gently in place against the underside of the pontoon (**Figure 24**). Lines were attached to both ends of the tube and secured in place on the pontoon superstructure. Once all the tubes were in place a walkway-sized bag was fitted over the whole pontoon.

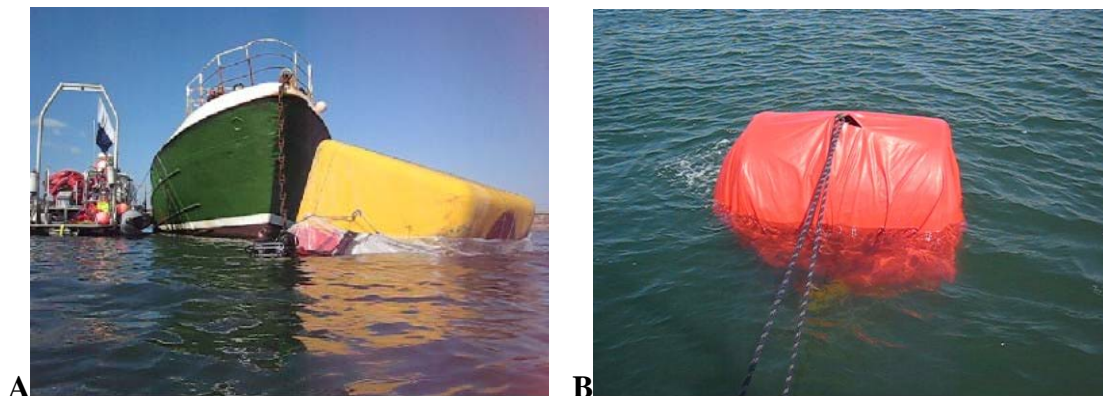
**Figure 26** Wrapping large mooring buoys. A, Largest of the mooring buoys treated; B, Medium-sized buoy wrapped using two adapted finger pontoon bags.

A combination of 500 gsm plastic and ‘internode’ bags were used to wrap the largest mooring buoys situated just north of the marina (**Figure 26**). Other medium-large buoys were treated using finger pontoon bags adapted to accommodate chains and mooring eyes. Calcium hypochlorite was used to accelerate the treatment in some cases.

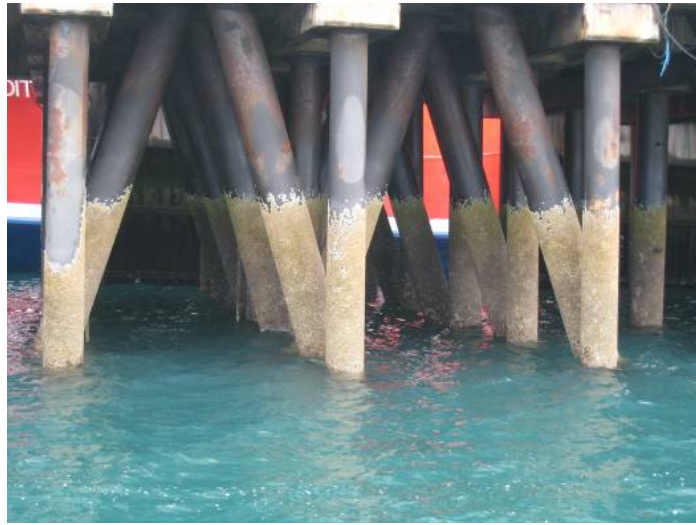
**Figure 33** Pilings and the survey pattern for investigating the Tinto jetty.

The divers developed patterns of searching appropriate to each type of structure. They concentrated on working below the low water mark and avoided searching over fine mud, structures devoid of other marine life and freshly cleaned surfaces. Structures such as the Tinto aluminium jetty and ferry terminals, which have many vertical stanchions and pilings reaching in to deep water, were best surveyed by spiraling up or down each structure but navigating horizontally between them underwater at around 4-10 m depth without surfacing between each one. This was primarily to avoid saw-tooth diving profiles which can be hazardous, by inducing decompression illness, to the divers (**Figure 33**).

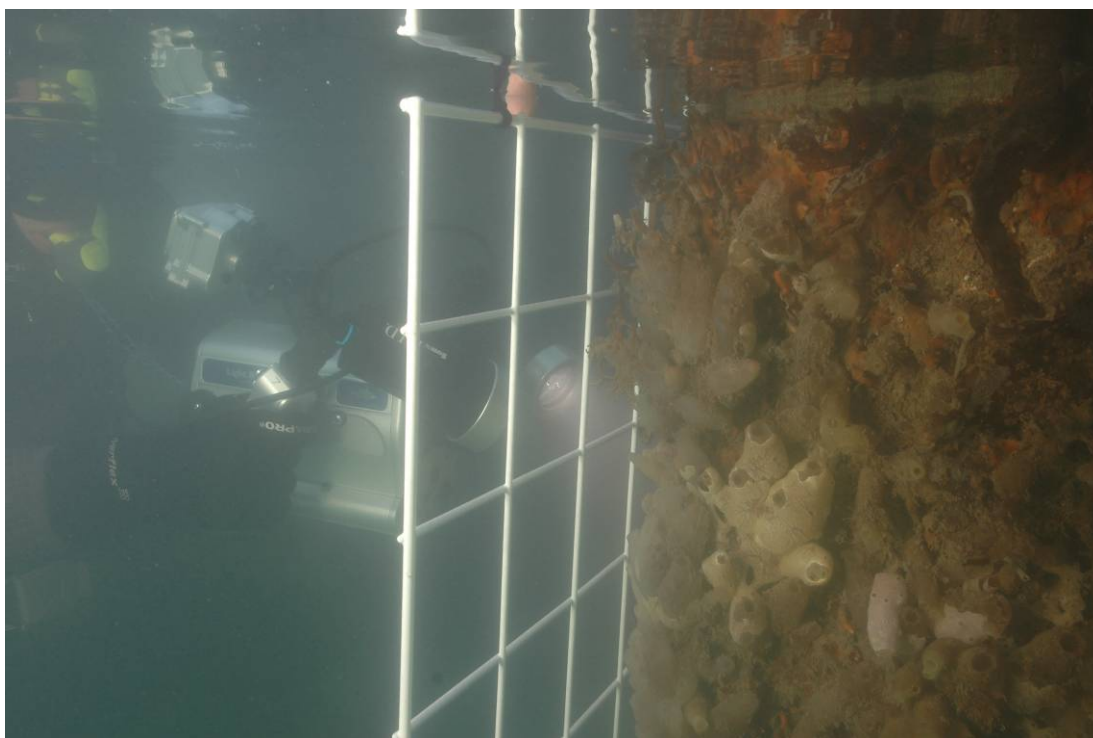
**Figure 37** Video quadrat method.

Best results are achieved by moving the video slowly and steadily from quadrat sub-cell to sub-cell and pausing on each cell for approximately four or five seconds (see also Figure 37).

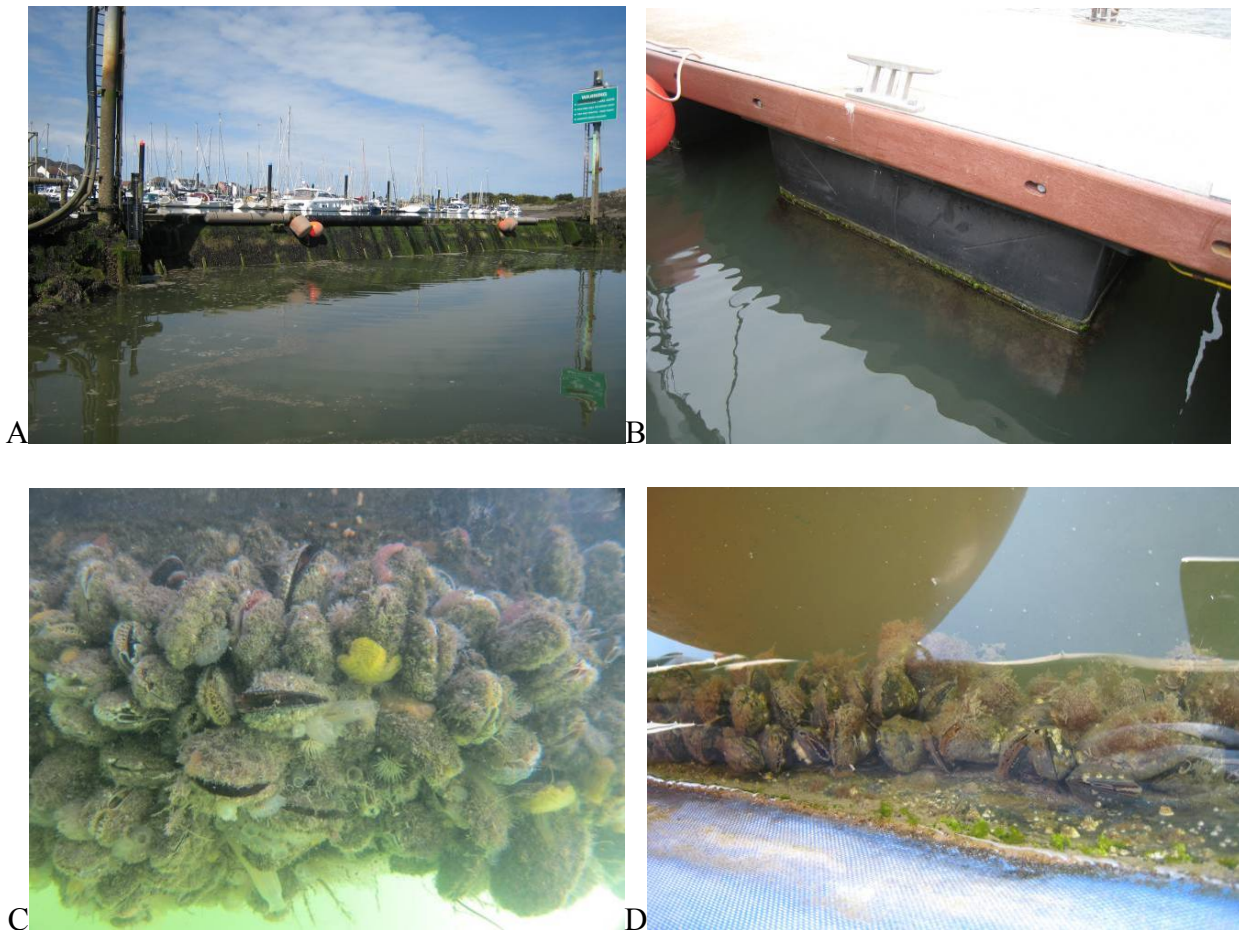
**Figure 40** A, Tidal sill at Conway marina; B, Fouling biota at Victoria Dock, Caernarfon; C, Fouling biota at Neyland marina; D, Fouling biota at Conwy marina

Other marinas around Wales incorporate a tidal sill or lock gates, restricting the flow of water for up to 12 hours a day. Many tended to have fresh water inputs from rivers or storm drains, resulting in reduced salinity particularly after heavy rain. Such situations are unlikely to be suitable for colonization by *D. vexillum* (Table 5).

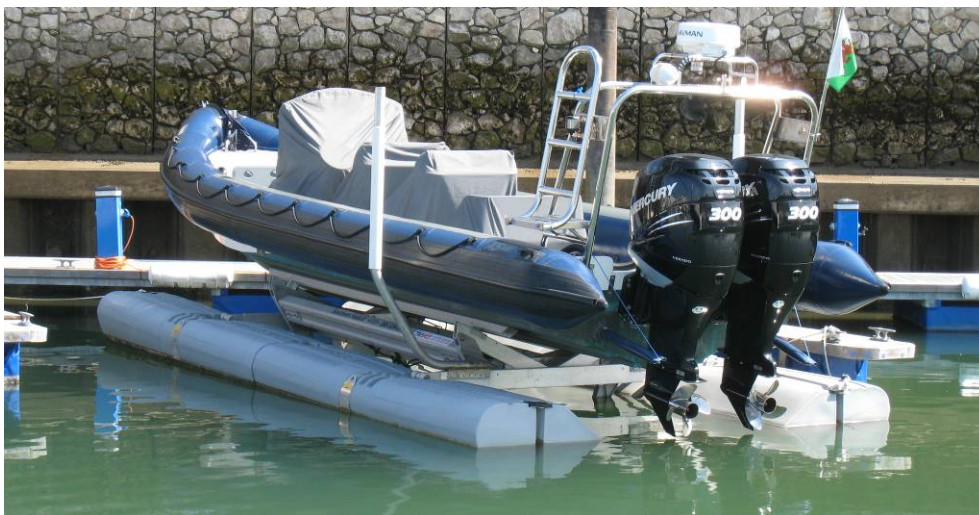
**Figure 46** Photo: R. Holt. *Sunstream* boat lift supporting an rigid hulled inflatable at Deganwy marina, Conwy.

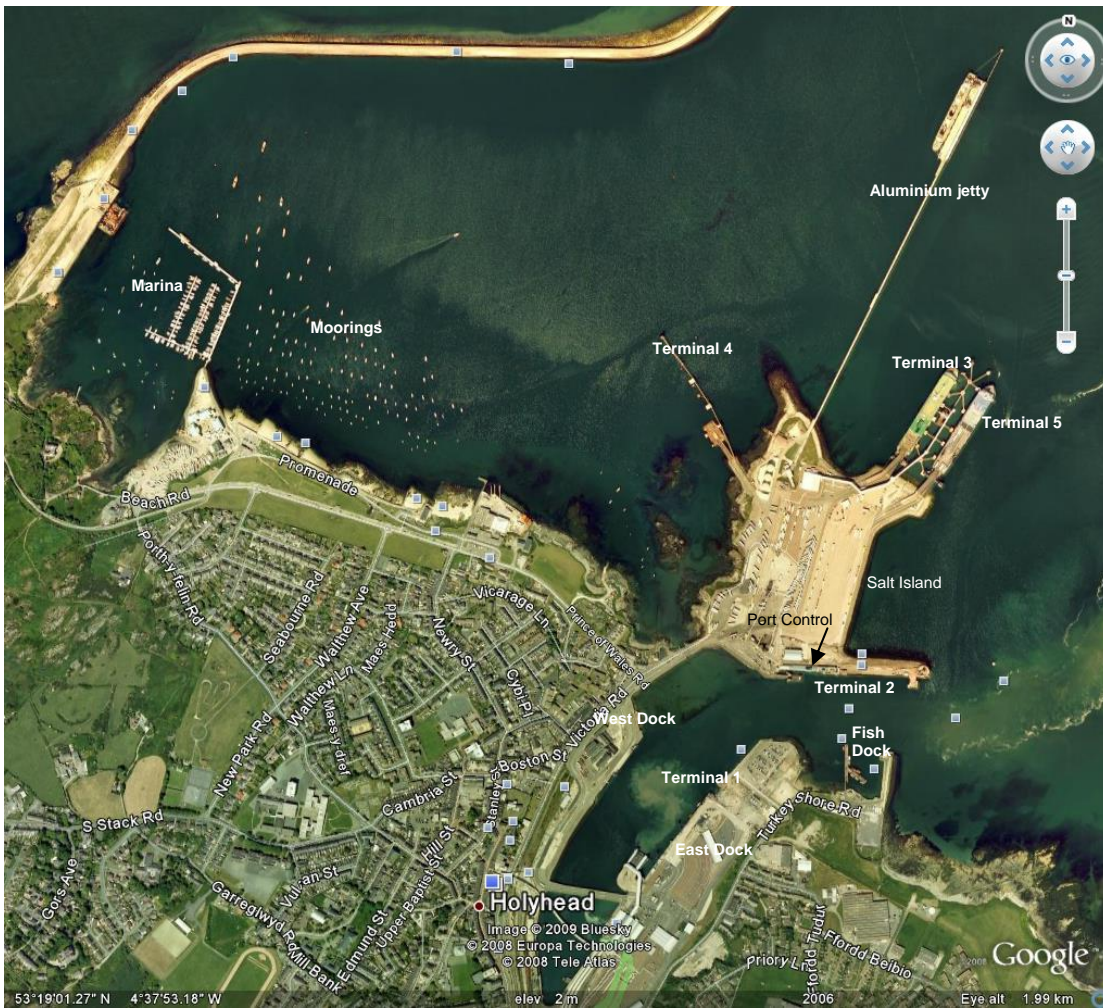
Annotated Google aerial view of Holyhead Harbour showing location of shipping terminals, moorings and marina.

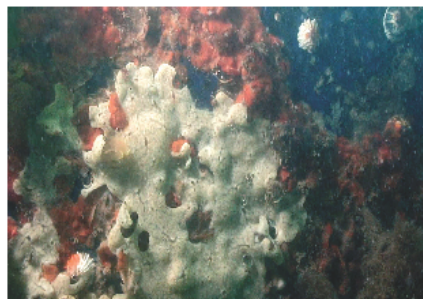
Carpet Sea Squirt colony growing on the hull of a heavily fouled vessel
