**Survey of a non-native ascidian (sea squirt)
Didemnum vexillum in Holyhead Harbour
February 2009**

CCW Marine Monitoring Report No. 67

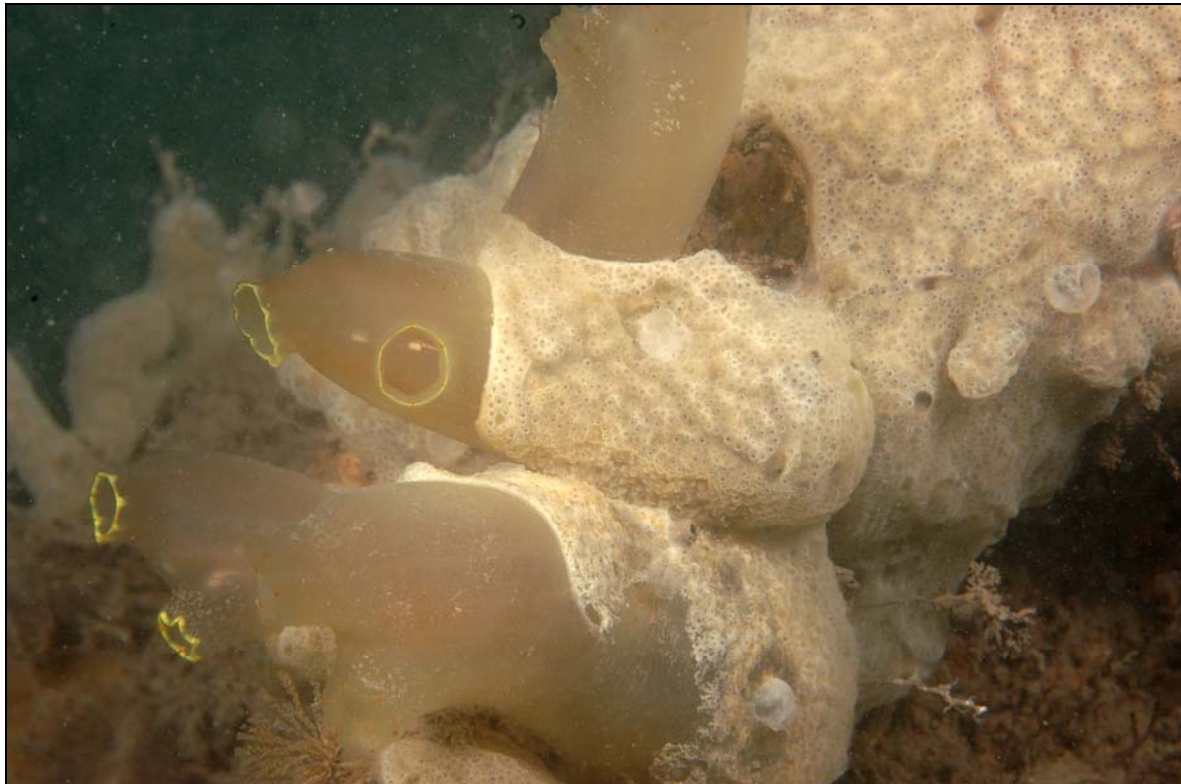
Didemnum vexillum colony overgrowing solitary ascidians *Ciona intestinalis* on marina mooring chains (image: Rohan Holt, CCW).

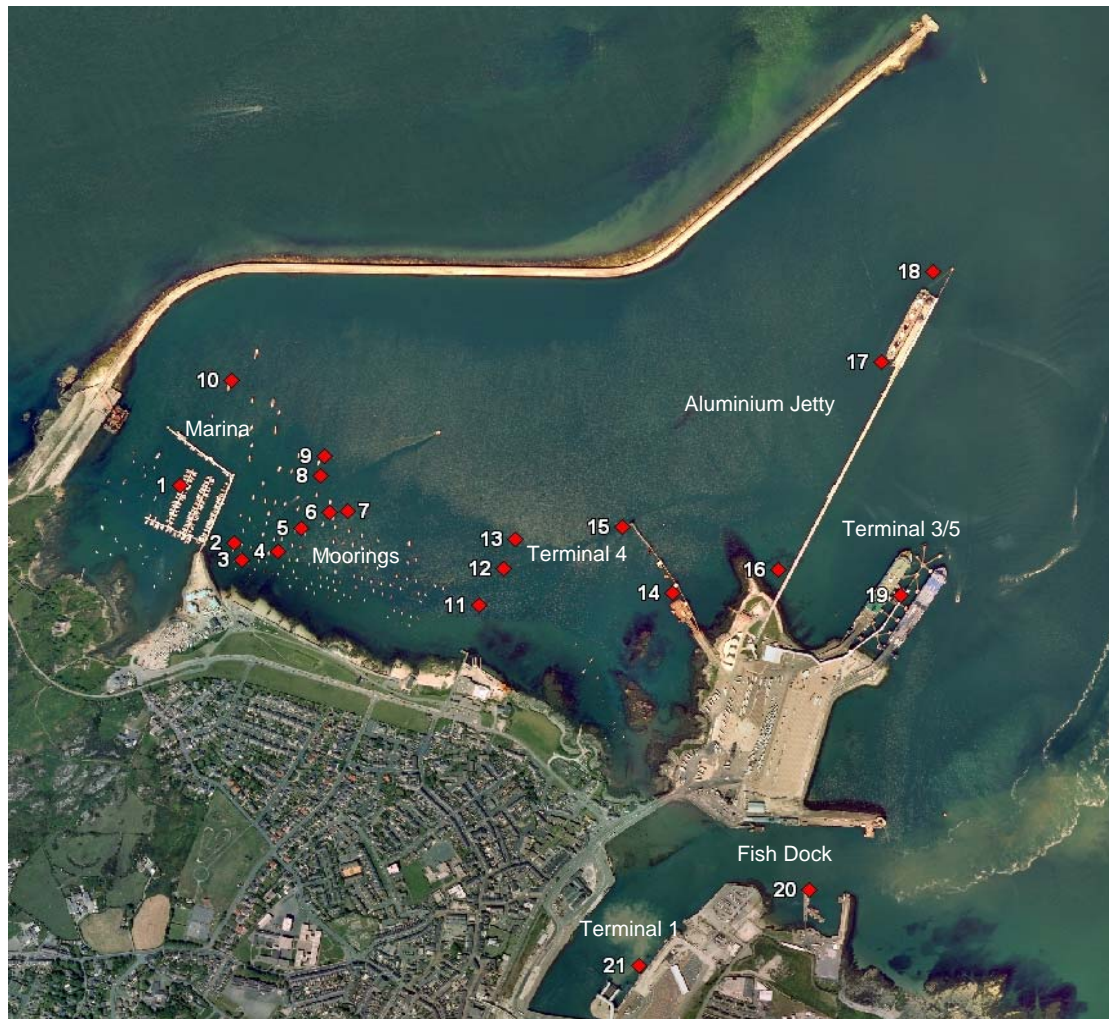
Figure 1. Aerial view of Holyhead Harbour where **◆** indicates survey location.

- Terminal 1 – sea walls and 2 piles at the HSS berth (2 pairs of divers)(21 in Fig. 1).
- Terminals 3 and 5 – three rows of piles form two adjacent terminals used by the large Stena and Irish Ferries. One large pile on each terminal was surveyed by a single pair of divers (19 in Fig. 1).
- Terminal 4 – two dives: piles on the far end and landward end of the jetty using one pair of divers (14 and 15 in Fig. 1).

- Aluminium Jetty – the long jetty used for unloading bulk aluminium ore carriers. Three stations were surveyed by one pair of divers: the seaward end, the landward end of the berth and the landward end of the jetty and adjacent hard substrata (16-18 in Fig. 1).
- Fish Dock – floating pontoon adjacent to the navigable channel into the inner harbour (20 in Fig. 1).
- Large-vessel mooring buoys that have vertical heavy chains to attach to mooring blocks and/or chains on the seabed. Four buoys surveyed by two pairs of divers in the outer harbour between the terminals and the marina (Photo 10) (10-13 in Fig. 1).

The yacht moorings to the east of the marina were examined by hauling the mooring ropes and steel cables aboard Pedryn's stern deck by hand at low water. This allowed inspection of each mooring's buoy, the surface to seabed rope attached to the steel cable and approximately 3-4 m of steel cable mooring. When not in use the steel mooring cables lie on the seabed at low water. Eight moorings were examined (2-9 in Fig. 1).

In summary *Didemnum vexillum* was not found anywhere in the harbour outside the marina area (See **Table 1** and **Figure 1** for overview)

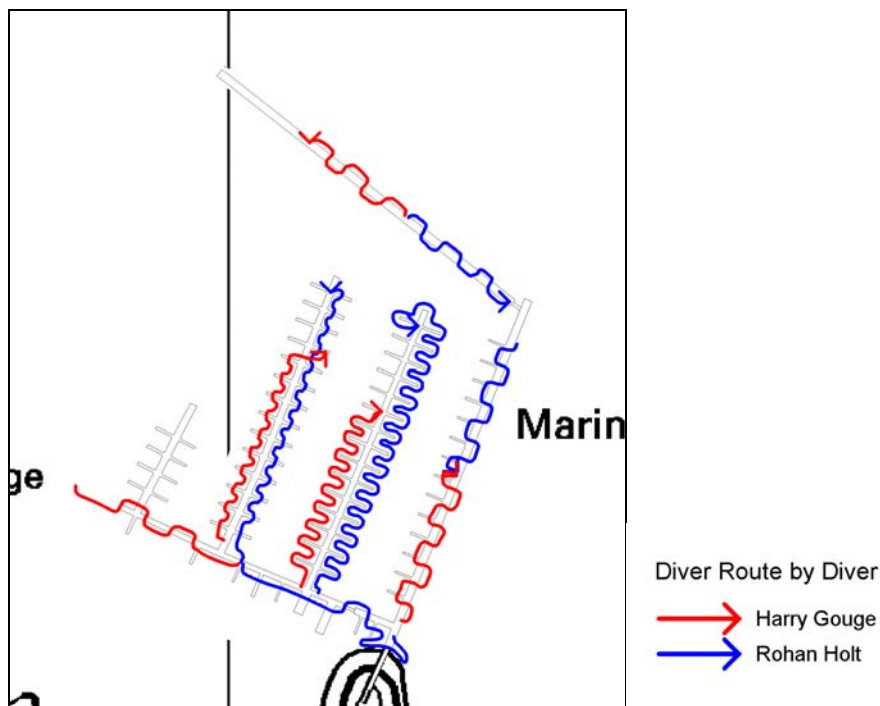
Figure 2: Route taken by the two divers around the marina

The route the divers took around the marina is illustrated in **Figure 2**.

- Sides of pontoons (no deeper than approx 1.5-2 m below sea level (bsl))
- Undersides of pontoons (approx 2 m bsl)
- Pontoon mooring chains and ropes (2-5m bsl)
- Concrete pontoon mooring blocks (3-5 m bsl)
- Hulls of vessels in the marina
- Seabed below the marina (3-6 m bsl)
- Rocky substrata under the walkway bridge at the entrance to the marina.

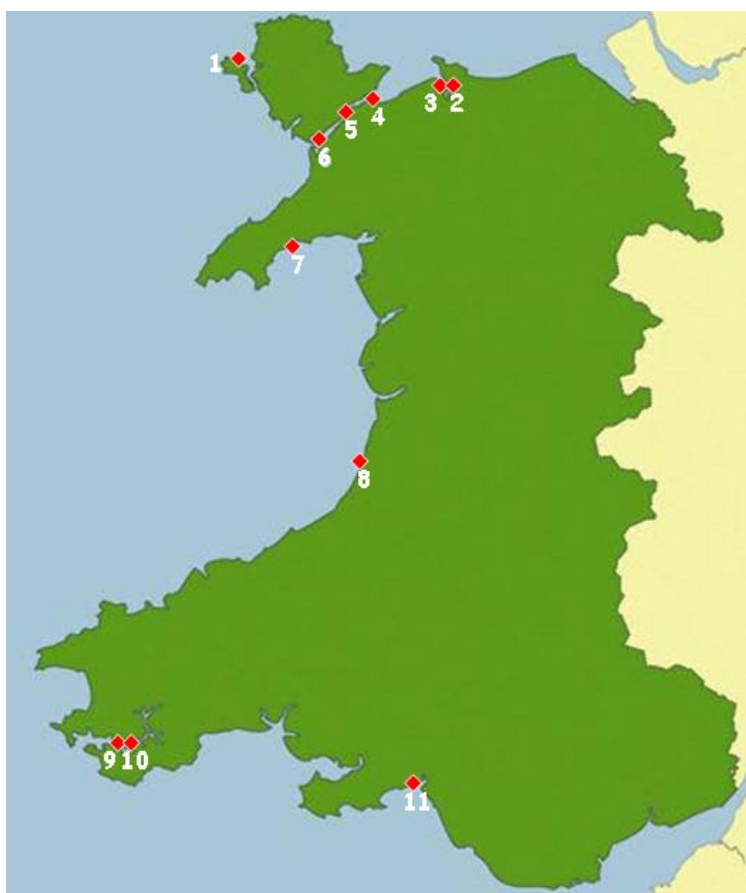
Figure 3. Distribution of marina/harbour sampling sites around Wales, see also Table 2 (Results section) for locations and position

Figure 3 shows the marina/port sites surveyed including Holyhead Marina (Site 1) and a further ten sites initially considered susceptible to the introduction of *D. vexillum* (see Table 2 for results). Sites 2-7 (Fig. 3) were initially investigated in December 2008 and January 2009 due to their close proximity to Holyhead Marina and the frequent interchange of vessels from the marina. Sites 8-11 (Fig. 3), further afield in west and south Wales, were examined between the 9th and 13th of February 2009.

At least two people visited each site to determine the presence of *D. vexillum*. All subtidal substrate that was visible from the pontoons was examined including pontoon surfaces, ropes, buoys and fenders. An underwater colour video surveillance system (Videotech VT-21111) with attached Sunray HID light and flexible handle was used to survey surfaces that could not be observed from the pontoons, such as the underside of pontoons, marina walls and pilings to 3 m below sea surface. All surveys were timed to coincide with low water to optimise the area of marina structures that could be searched.

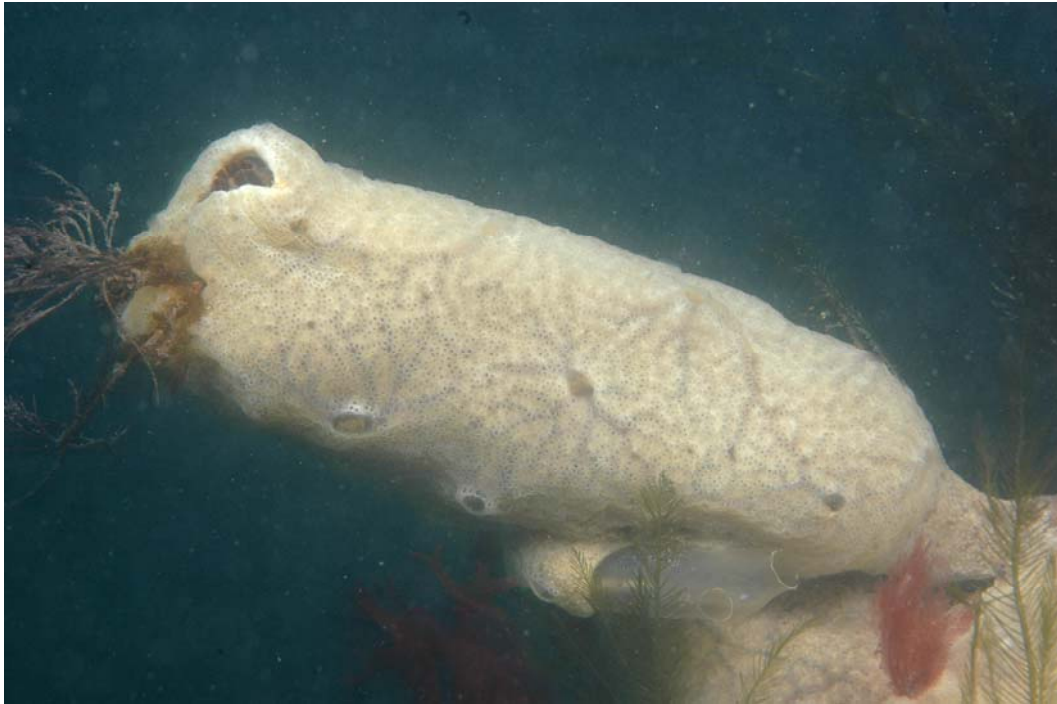
Photo 1. *Didemnum vexillum* overgrowing *Styela clava* (R. Holt CCW)

Divers retrieved specimens by hand from a range of different locations and substrata. Those easiest to collect were found overgrowing the abundant solitary ascidians such as *Ciona intestinalis*, *Asciella aspersa*, *Styela clava* (photos 1-4) on the marina pontoon mooring chains and the permanently submerged sides of the pontoons. In such cases the 'host' ascidians were collected whole. Thin sheets of *D. vexillum* were also removed from the marina pontoon sides using a flat-bladed knife.

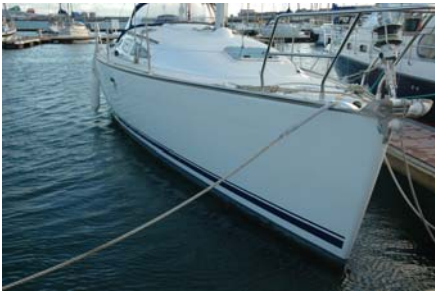
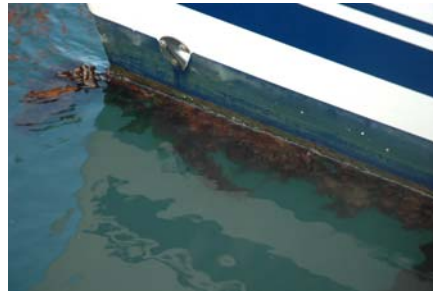
Photos 5 – 6.

The density of flora and fauna colonising both vessels indicated that neither had probably moved far in the last 12 months. Both had large *Saccharina latissima* sugar kelp plants and other algae, mature mussels *Mytilus edulis*, feather stars *Antedon bifida*, large solitary ascidians including *Styela clava*, *Asciidiella aspersa* and *Ciona intestinalis* as well as other encrusting fauna such as barnacles and bryozoans. *Didemnum vexillum* was found encrusting parts of the propeller shaft and the rudder on a yacht (see video stills) and also encrusting some of the mussels on a motor vessel's hull.

Heavily fouled yacht (photo: K Ramsay). Although everything above the waterline on this yacht appears to be pristine, large algae and kelp plants are visible from the surface and *Didemnum vexillum* was found on the prop-shaft and rudder as seen on the following stills taken from the video.

Contaminated recreational vessels should be brought ashore and jet-washed or scrubbed clean. Any debris should be allowed to dry and/or decompose but not be returned to the water.

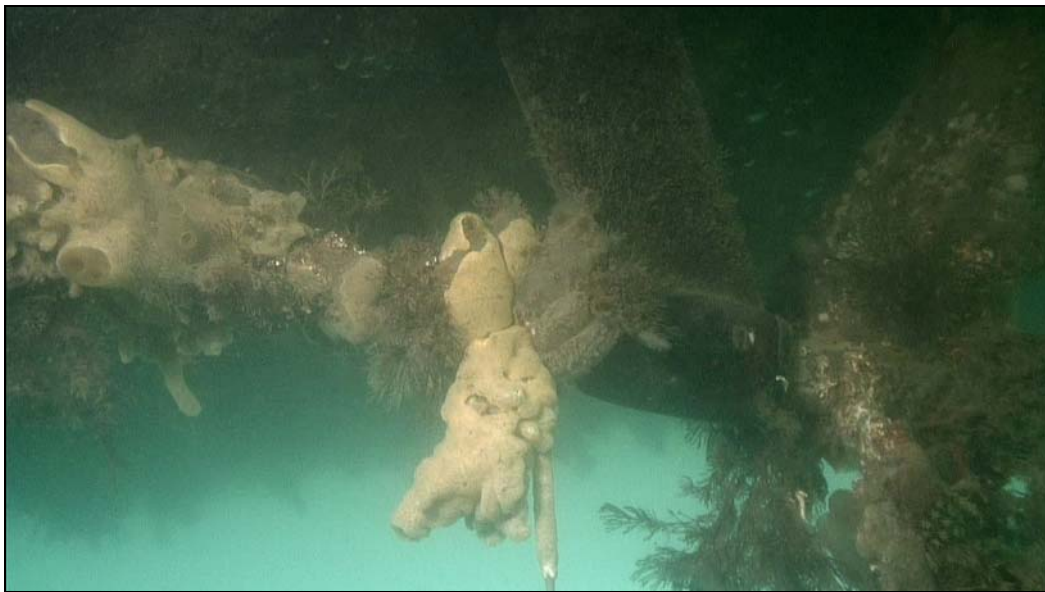
Photo 7. Large colonies of *Didemnum vexillum* on the prop-shaft and covering other solitary ascidians. The propeller is to the right of the picture (from video: H. Gouge).

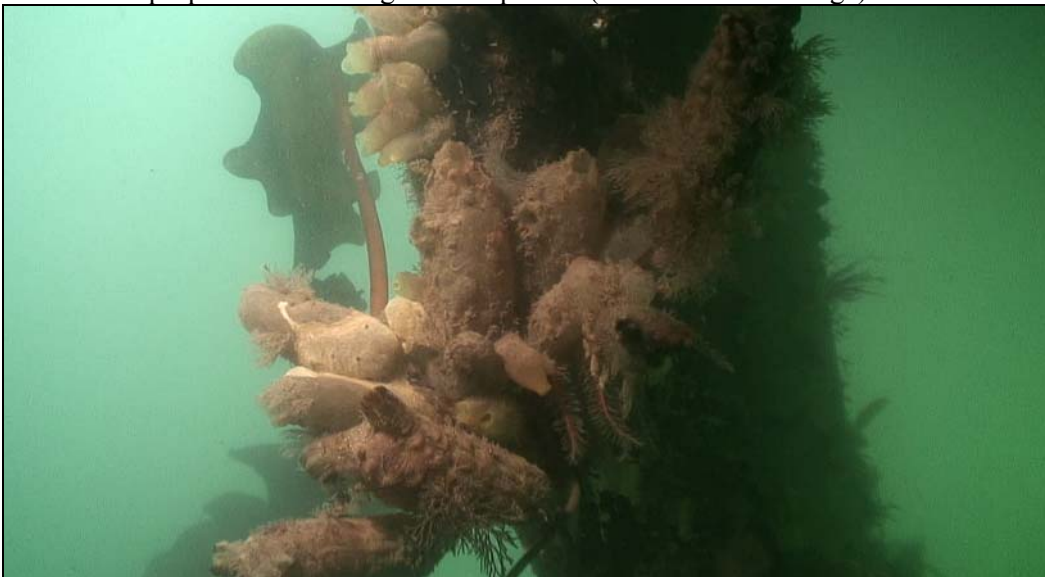
Photo 8. Kelp and solitary ascidians *Styela clava* and *Ascidiella aspersa* attached to the rudder. *Didemnum vexillum* is the pale-coloured coating on some of the ascidians (from video: H. Gouge).

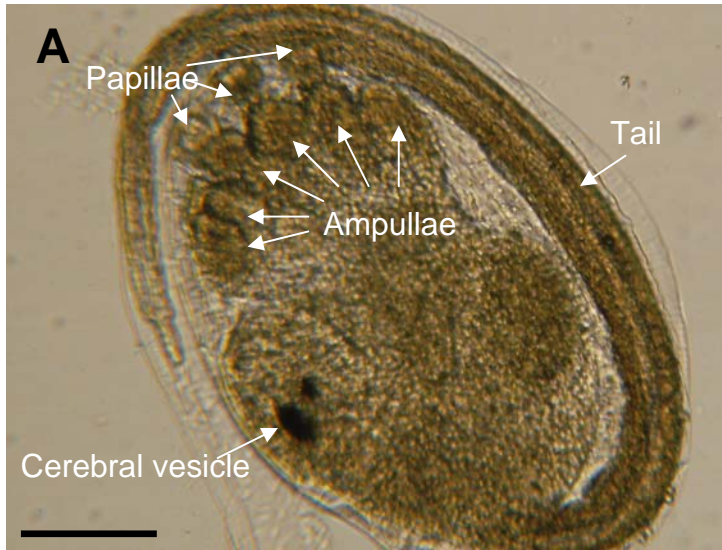
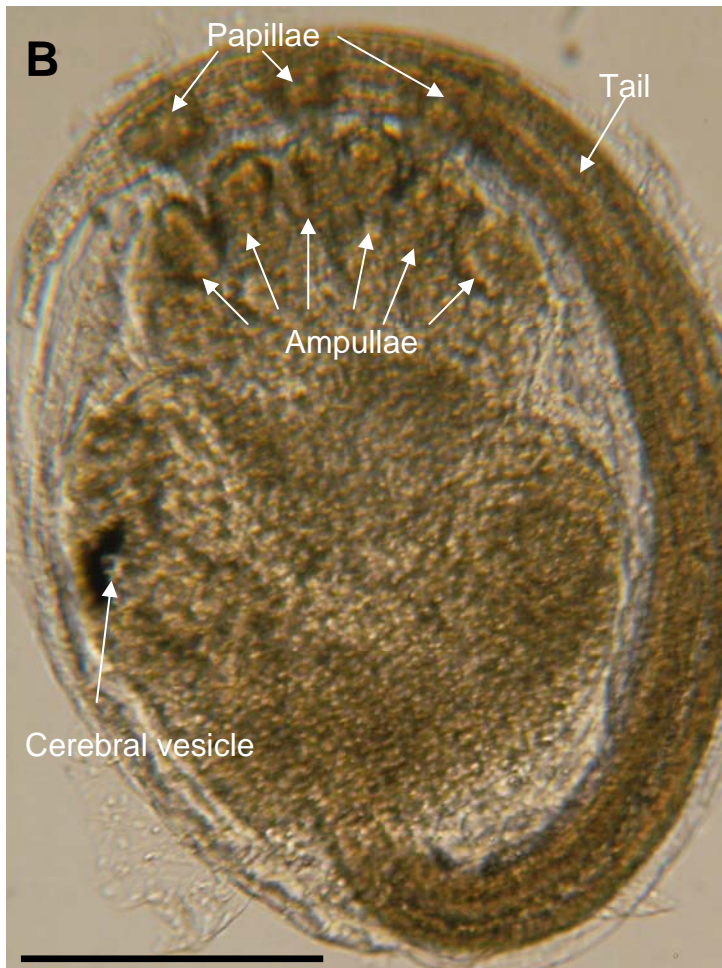
Photos 9 A & B

Didemnum vexillum brooded unhatched larvae. Removed from colony sampled during the December 2008 phase of the diving survey.

The appearance of the larvae in this sample matches those described by Lambert (2009): six pairs of lateral ampullae and three adhesive papillae.

Adult colony features also match: yellowish cream colouration; spicule-free bands between zooid groups; colony form - thin to thick encrusting to lobed.

Photos taken using LCD microscope. Scale bars are 0.2 mm
