**Yorkshire
Wildlife Trust**

YWT's
Restoration Trial

Project Background

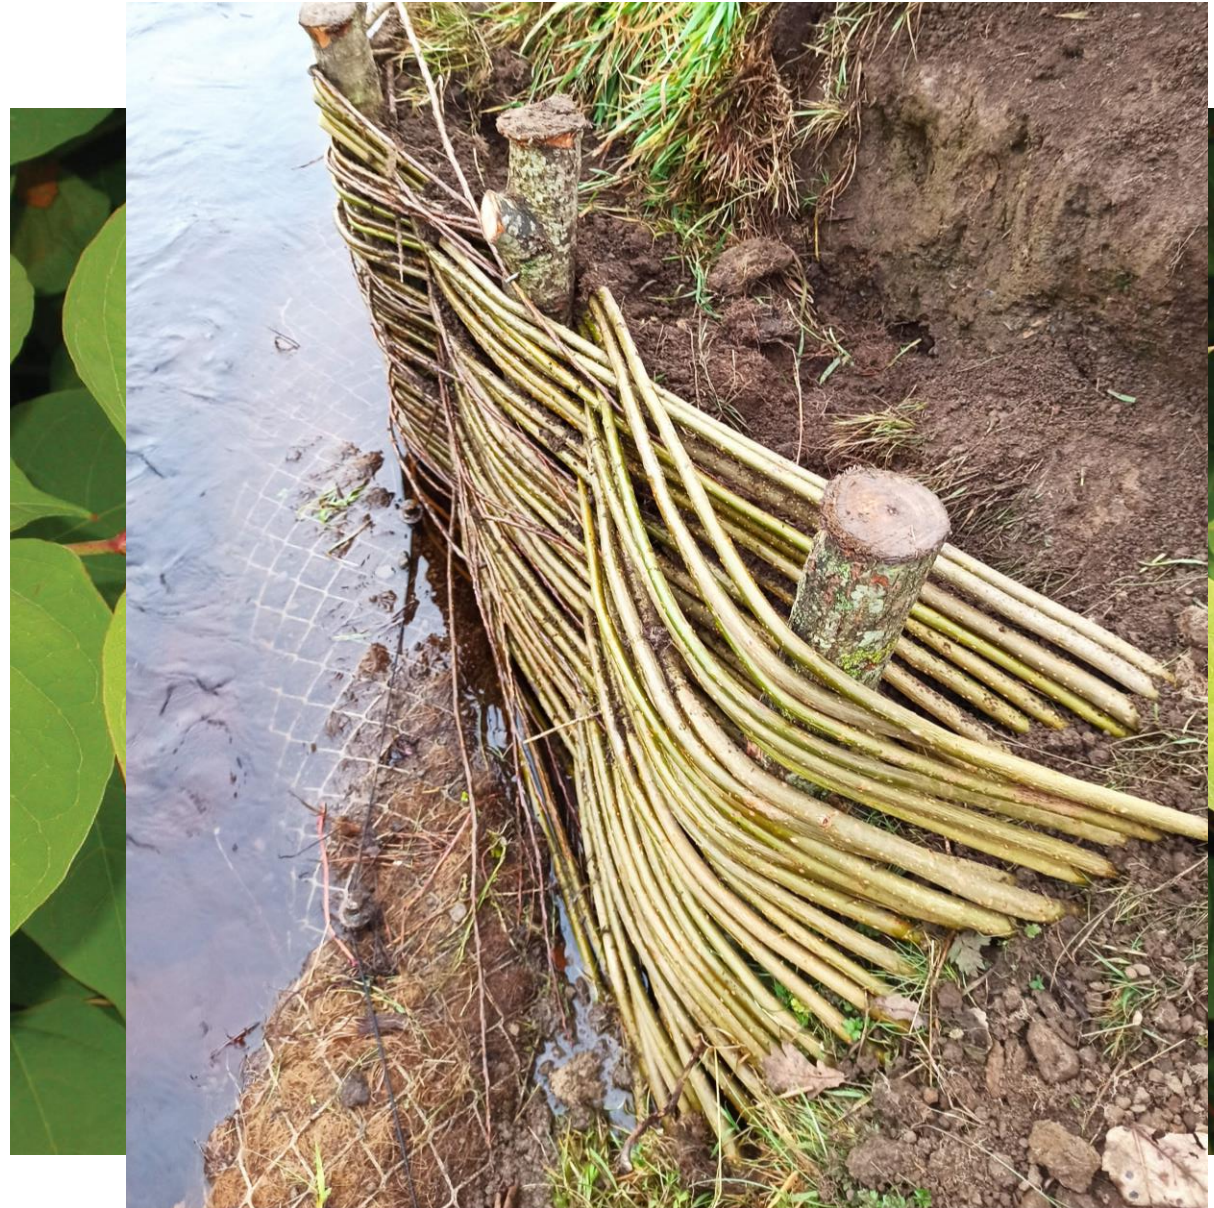
- **Post Japanese Knotweed Treatment**

Bare ground, close to river.
High erosion or secondary
infestation by Himalayan
Balsam

- **Restoration issues**

We were seeing heavy
erosion in post treatment
areas, reduced species
diversity and potentially
reduced flora resilience for a
possibly changing climate

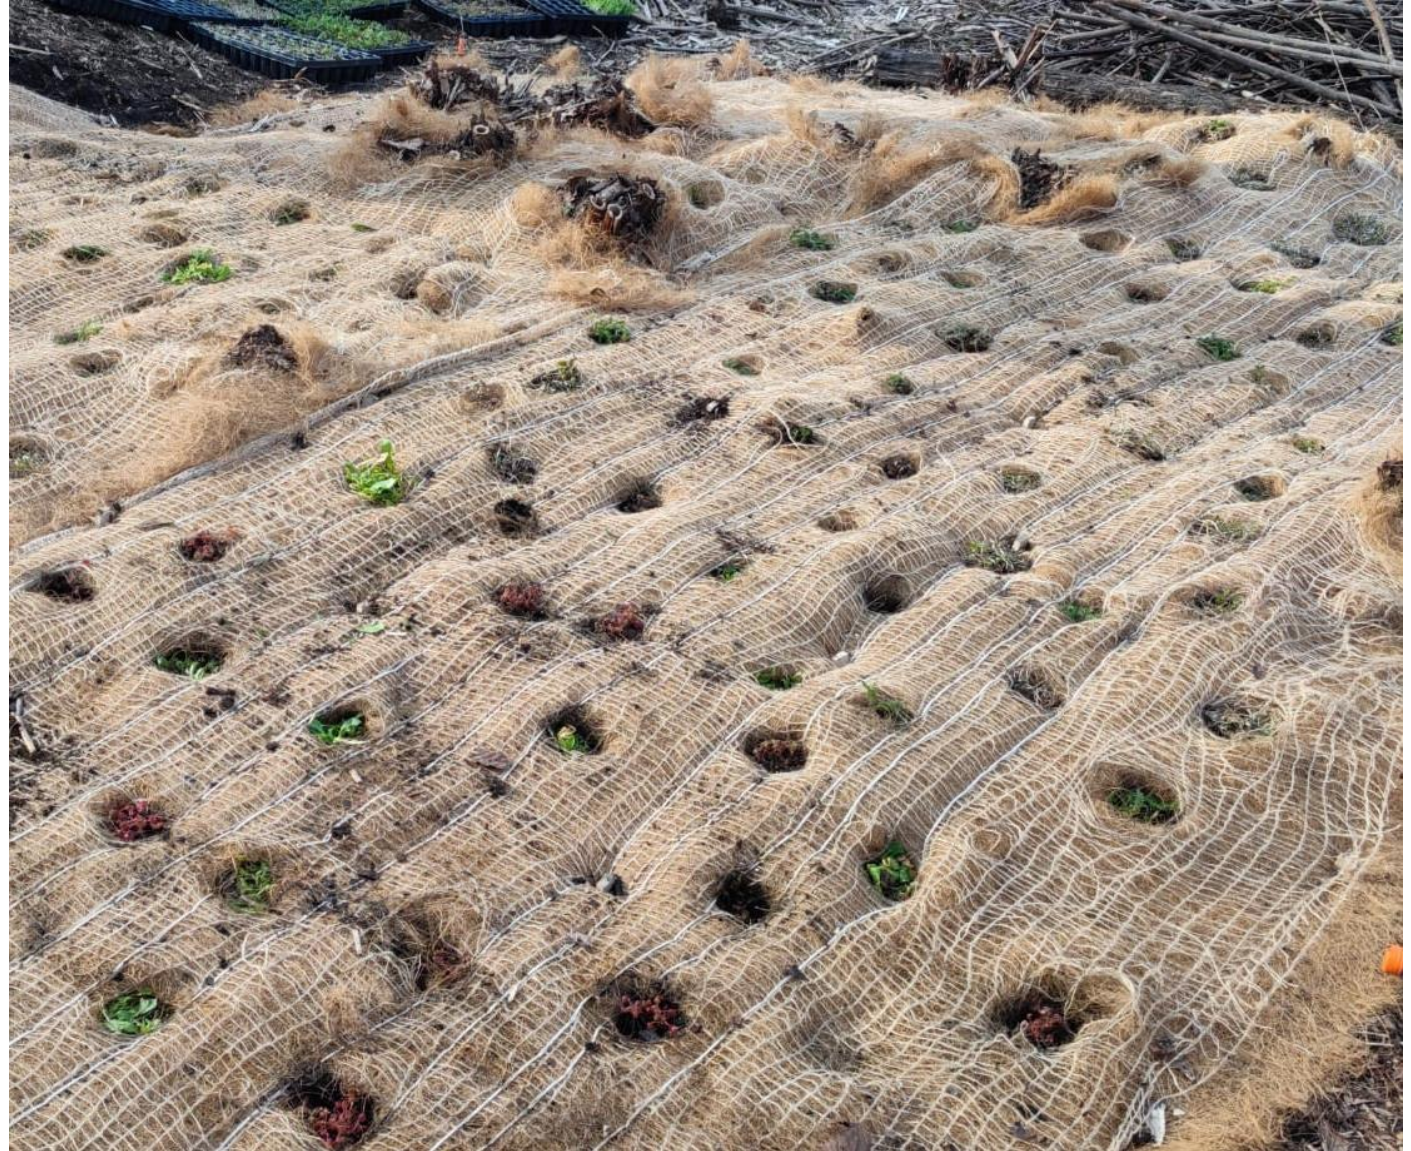
The Plan

- **4 Sections**

Section 1: No Treatment and no AC

Section 2: No Treatment and AC

Section 3: Treatment and no AC

Section 4: Treatment and AC

- **5 restoration methods in each section.**

1. Control (no restoration)
2. ECB + Grass Seed
3. ECB + Riparian Seed
4. ECB + Plug Plants.
5. ECB only
